Inspection Report

PROPERTY INSPECTION REPORT

Report No:	<u>423423</u>	Report Date:	<u>2/2/2009</u>
Prepared For:	<u>John Doe</u> (Name of Client)		
Concerning:	<u>4458 Alton Parkway</u> <u>Arlington TX 76006</u> (Address or Other Identification of Inspected Property)		
By:	<u>Sam Eagleye</u> <u>TREC #557856</u> (Name and License Number of Inspector)		
	<u>John Doe</u> <u>TREC #12345</u> (Name of Sponsoring Inspector and License Number of Sponsoring Inspector, If required)		
Inspection Date:	<u>1/15/2009</u>	Time:	<u>9:52:03 AM</u>
		Outside Temp:	<u>54°F</u>
		Weather:	<u>Clear</u>
Age of Home:	<u>5-10</u>	Occupied:	<u>No</u>
		People Present:	<u>Vacant</u>

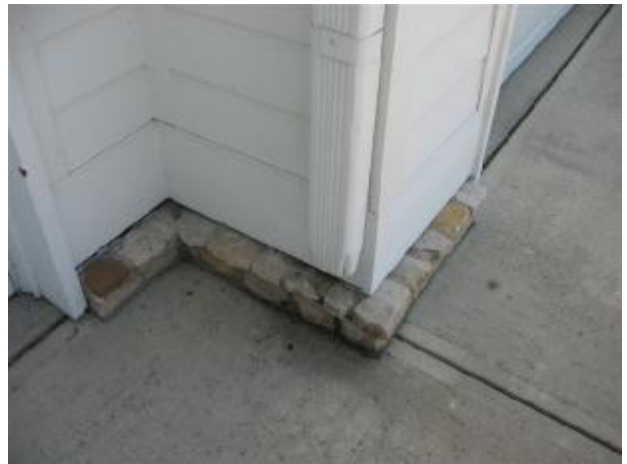
I12

Elbow missing from the north side of double vehicle door (see photo ID12)

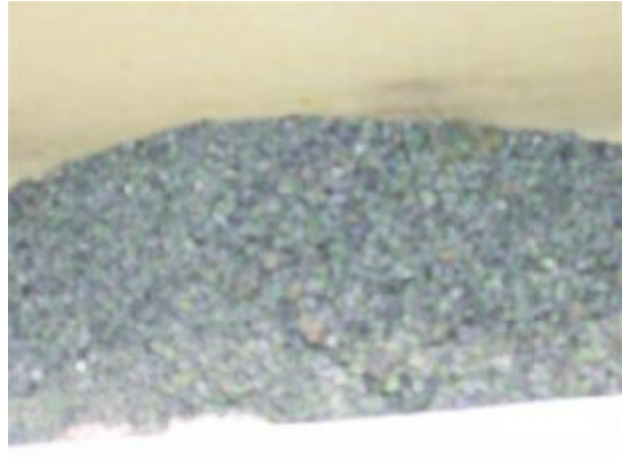
I14

There is a very heavy collection of roofing aggregate in the gutters. Excessive heat can cause aggregate loss and reduced shingle life (see photo IC14).

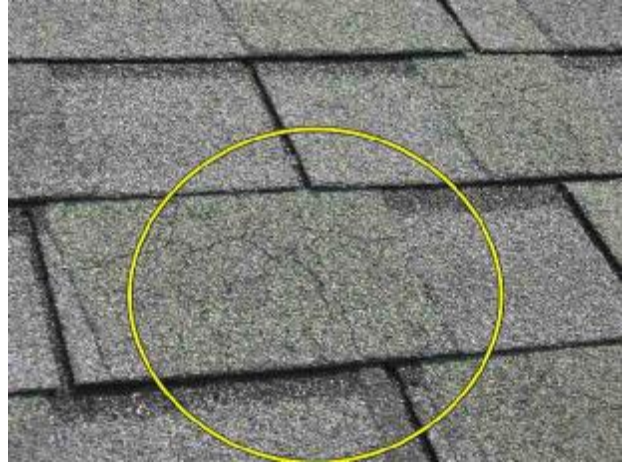
I16

Inadequate ventilation in attic resulting in premature aging of shingles along the west (front) slope around the dormers. Recommend an improvement in ventilation and replacement of damaged shingles. Recommend evaluation by roofing contractor (see photo IC16)

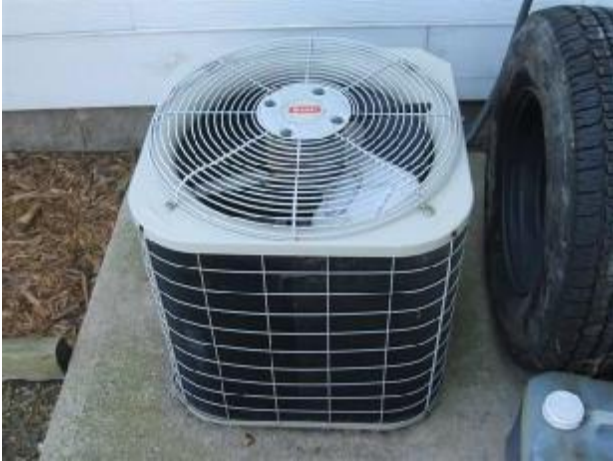
IIB1

Cooling System - Maintenance Item
Evidence of debris and dirt impacted in evaporator coils. Clean evaporator coils (see photo IIIB1)
