Inspection Report

Rich & Kathy Jordan
11601 Pebblepointe Pass
Indianapolis, IN 46204

Report Date: 6/19/2006

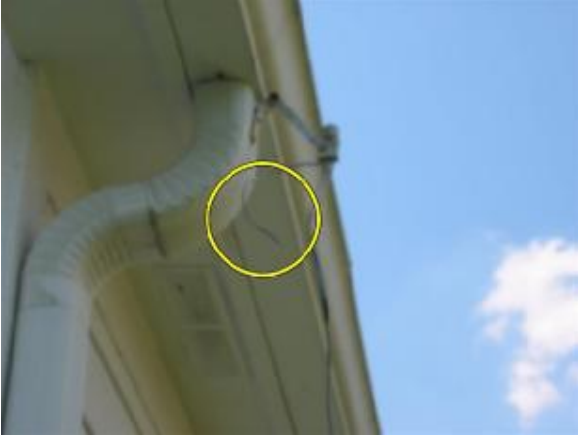
R1

19 Rain gauge wiring is hanging from gauge. Wiring should be fastened to downspout to prevent it from being torn loose (see photo 1).

Reattach rain gauge sensor wire

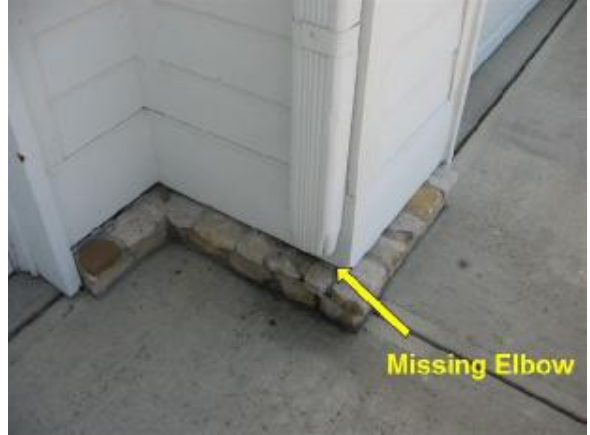
R2

Elbow missing from the north side of double vehicle door (see photo 2)

Missing Elbow

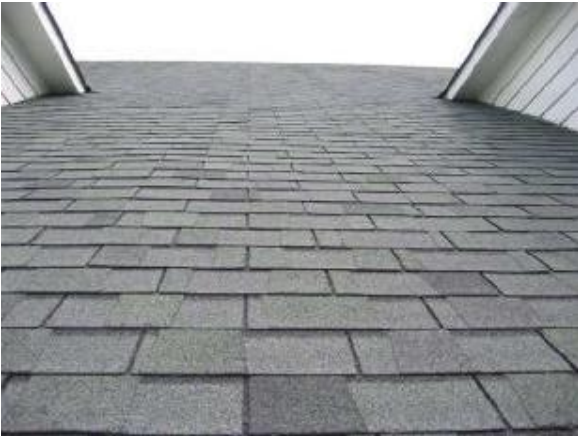
R3

Inadequate ventilation in attic resulting in premature aging of shingles along the west (front) slope around the dormers. Recommend an improvement in ventilation and replacement of roof shingles. (see photos 3 and Attic 1).

Inadequate ventilation in attic resulting in premature aging of shingles along the west (front) slope around the dormers. Recommend an improvement in ventilation and replacement of roof shingles. - Estimated Cost To Repair or Replace \$10,000.00

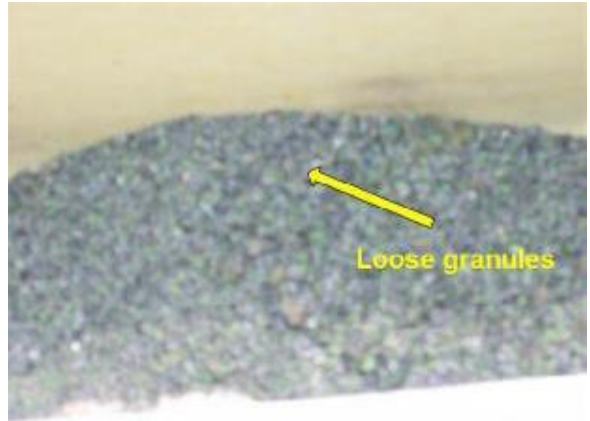
R4

There is a very heavy collection of roofing aggregate in the gutters. Excessive heat can cause aggregate loss and reduced shingle life (see photo 4).

Loose granules

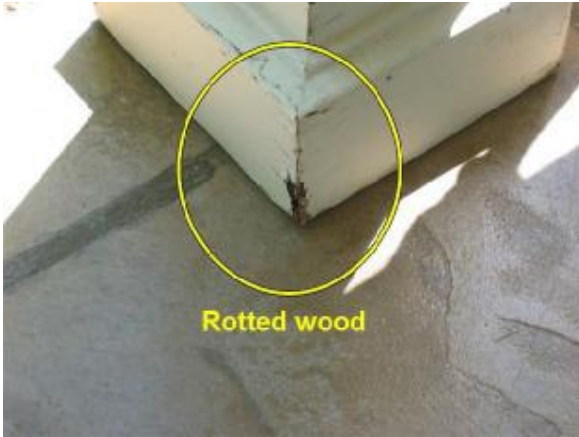
EX1

16 The wooden support posts for the porches on rear verandah rest on the concrete floor. The posts should rest on plates or be otherwise raised to avoid long term moisture contact (see photo 1). Recommend replacement of trim at base of all columns.

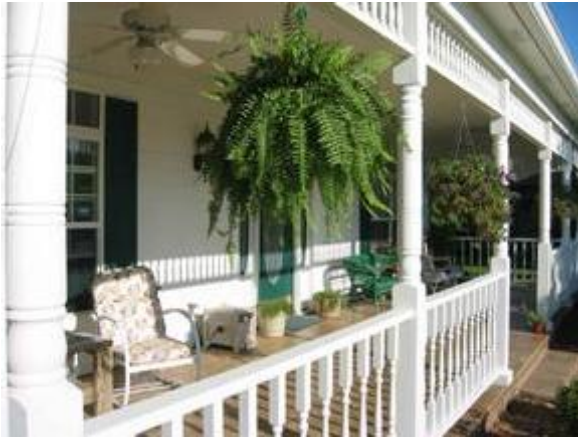
EX3

The exterior paint on trim is deteriorating and should be repainted. The railing system on the front and back porch contains numerous rotted boards which need to be replaced (see photo 3).

The exterior paint on trim is deteriorating and should be repainted. The railing system on the front and back porch contains numerous rotted boards which need to be replaced.

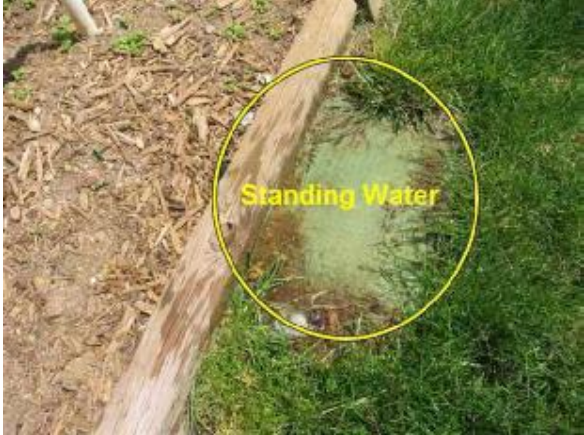
Grounds & Drainage # GD1

17 Sprinkler pit on south side of house is flooded. Unable to test system. Recommend evaluation by sprinkler system professional (see photo 1).

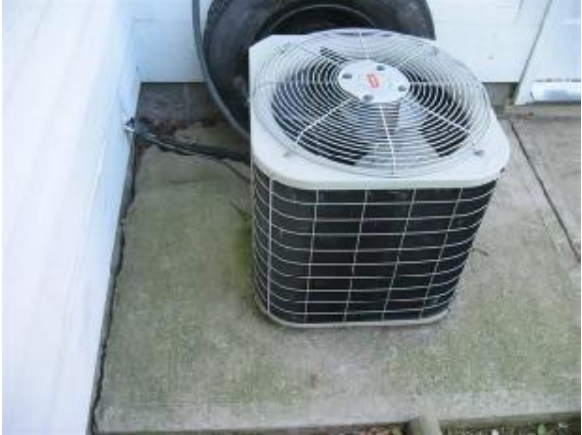
Grounds & Drainage # GD2

AC condenser slab slopes approximately 2" towards foundation. Recommend that slab be leveled to prevent water from flowing under slab (see photo 2).

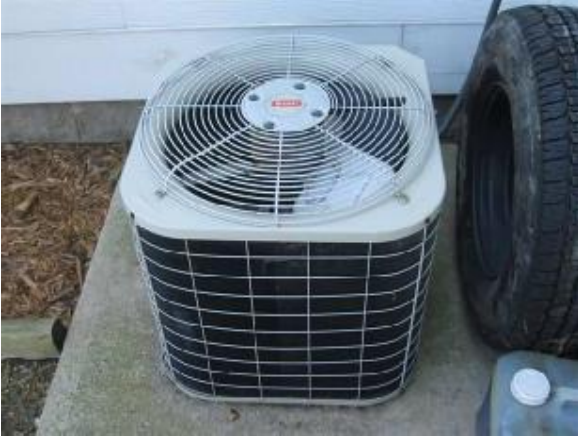
HC1

24 **There is some accumulation of dirt and debris on the condenser coils. Cleaning is recommended (see photo 1).**

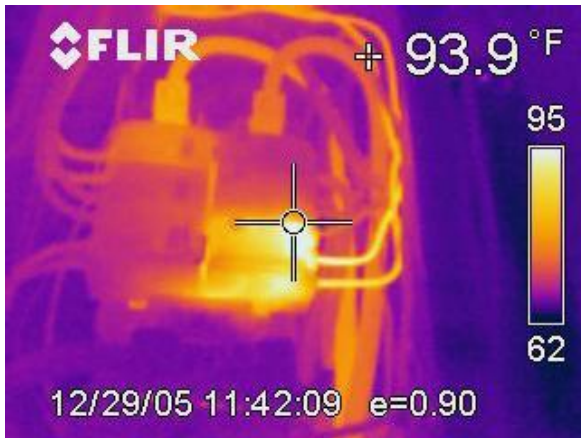
EL2

19 Hot spot observed in main panel (see photo 2). Recommend evaluation by licensed electrical contractor.

Hot spot observed in main panel. Recommend evaluation by licensed electrical contractor.

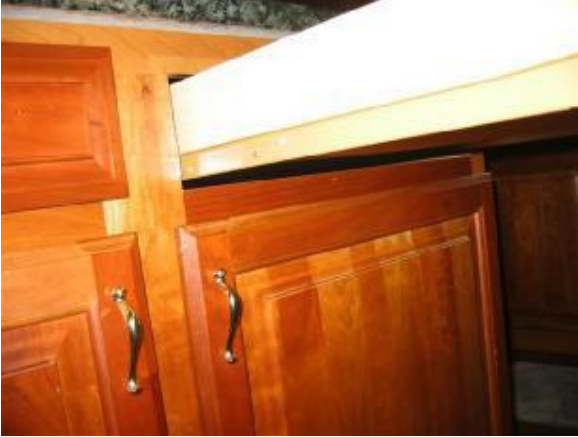
K1

26 Track on island drawer defective (see photo 1).

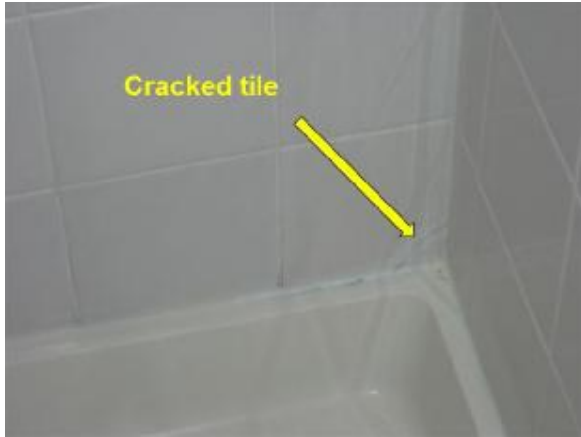
B1

14 Cracked tile in Master Bath shower has allowed moisture to penetrate the wall and floor around shower pan (see photos 1 & 2).

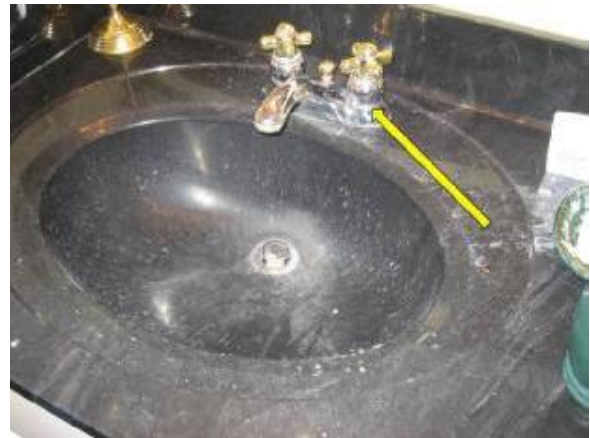
B4

Leaky cold water faucet in left sink of guest bath. Replace washer. (see photo 4).

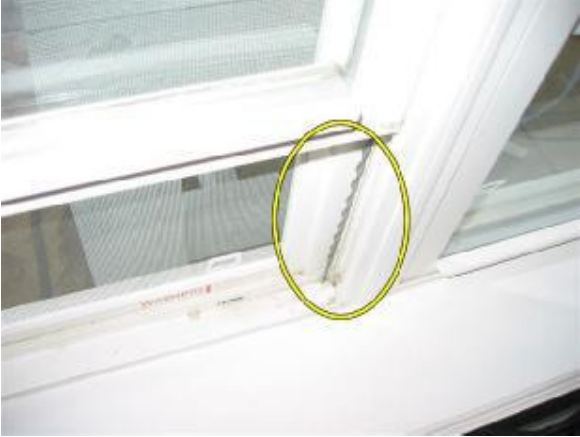
IR1

- 17 Double hung window at SE corner of living room is inoperative. (see photo 1).
- Many windows do not have screens installed. Inspector observed a stack of screens in attic.
- Sliding door guides at both of closet doors in Bedroom #2 missing.
